# BELZONA RECONSTRUCTS TURBINE BLADES AND IMPELLER

ID: 5091

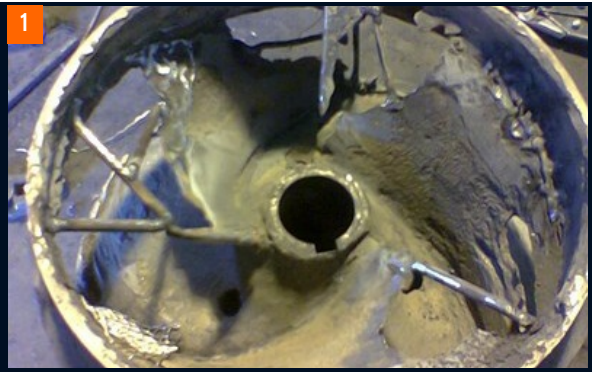
The worn-out turbine blades prevented the equipment from working properly.

1. Original conditions of the impeller. The damage is observed as well as the welded bars.
2. A wire mesh is placed to create the body of the turbine blades.
3. Belzona 1311 was applied to the impeller
4. Application completed.

The impeller was cleaned and the turbine blades were repaired to its original dimensions. In order to achieve this, bars were welded to define the area and provide support. Then, a wire mesh was placed with the goal to strengthen the repair and define the body of the turbine blades, in order to later apply Belzona 1311. Application was carried out in accordance with a modified version of Belzona Know-How System Leaflet CEP-1.
