# HYDRO TURBINE GUIDE VANES REPAIRED AND PROTECTED WITH BELZONA

ID: 5158

Erosion and cavitation of turbine vanes

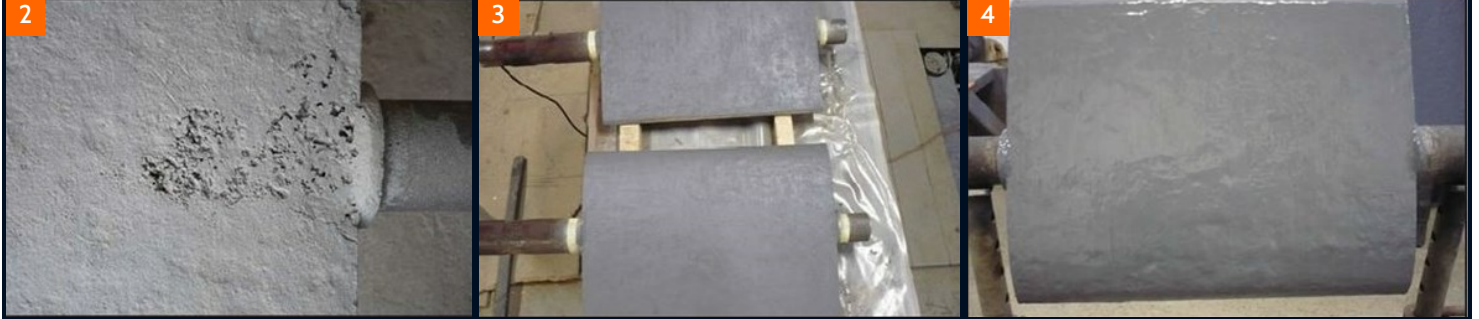
Erosion/corrosion and cavitation by pressure to the face of turbine guide vanes revealed during annual inspection

1. General view of the turbine guide vanes surface preparation
2. Grit blasting of the turbine guide vanes
3. Geometry of guide vanes repaired using Belzona 1311
4. Repaired surfaces of the guide vanes after the application of Belzona 1311 and Belzona 1321

The application was carried out according to Belzona Know-How System Leaflet CEP-1 and FBC-2. Belzona 1311 was used to resurface the profile. Belzona 1321 was applied to improve efficiency and protect against erosion/corrosion.
