# HYDRO TURBINE REPAIRED AND PROTECTED WITH BELZONA

ID: 5159

Power plant, Ukraine

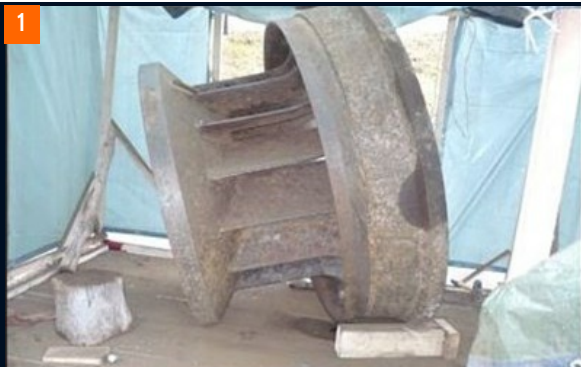
Erosion-corrosion and cavitation of the fan blades and of the face of the hydro turbine due to pressure

1. General view of the impeller Surface preparation
2. Grit blasting of the turbine
3. Geometry of fan blades repaired using Belzona 1311
4. Repaired surfaces of the hydro turbine after the application of Belzona 1311 and Belzona 1341
