# BELZONA REPAIRS DAMAGED WASTEWATER PUMP

ID: 5169

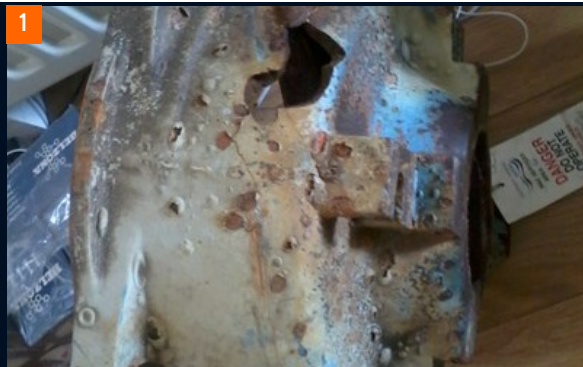
Erosion from solid material in process fluid had destroyed impellor and holed casing of a wastewater pump.

1. Holed pump casing
2. &3. Pump casing rebuilt with Belzona
