# BELZONA REPAIRS CABLE REINFORCED CONVEYOR BELT

ID: 5184

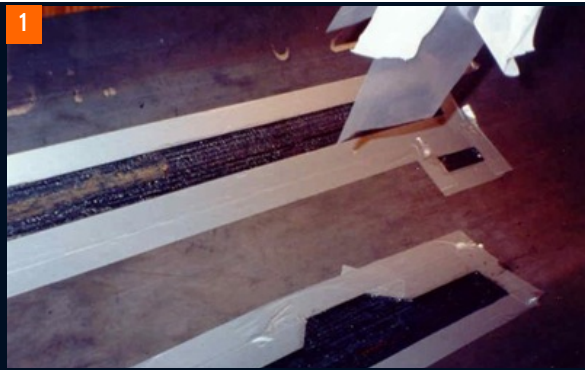
1. View of preparation in progress
2. Close-up of one of the repair areas
3. Completed application.

Application carried out in accordance with Belzona Know-How System Leaflet SHM-1

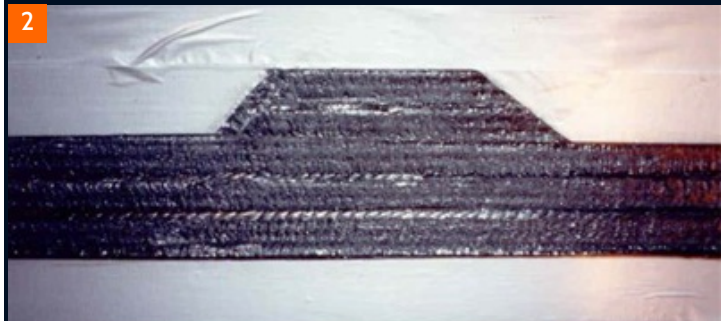
Cable stayed belt would develop cracks over a period of time.
