# BELZONA REBUILDS DAMAGED PUMP FLANGE

ID: 5193

Broken flange on pump

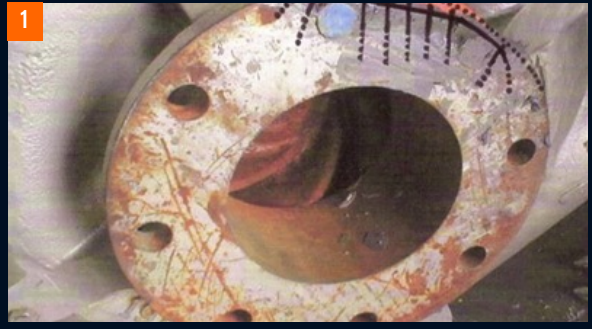
The cast iron pump casing had fallen off a pallet breaking part of the flange.

1. Diagram showing support cage fabricated for the damaged area
2. Rebuilding in progress
3. Rebuilt flange

After tapping a number of holes along the broken flange edge, a reinforcement cage was bonded into place around the edge using a welding rod to provide some structural integrity to the area to be rebuilt. Once in place the various pieces were tack welded together.
