# BELZONA REPAIRS AND PROTECTS THE LINING OF FLOTATION CELLS

ID: 5210

## PROBLEM

Copper pulp leak through the bottom of the flotation cell due to corrosion and localized worn areas with severe abrasion.

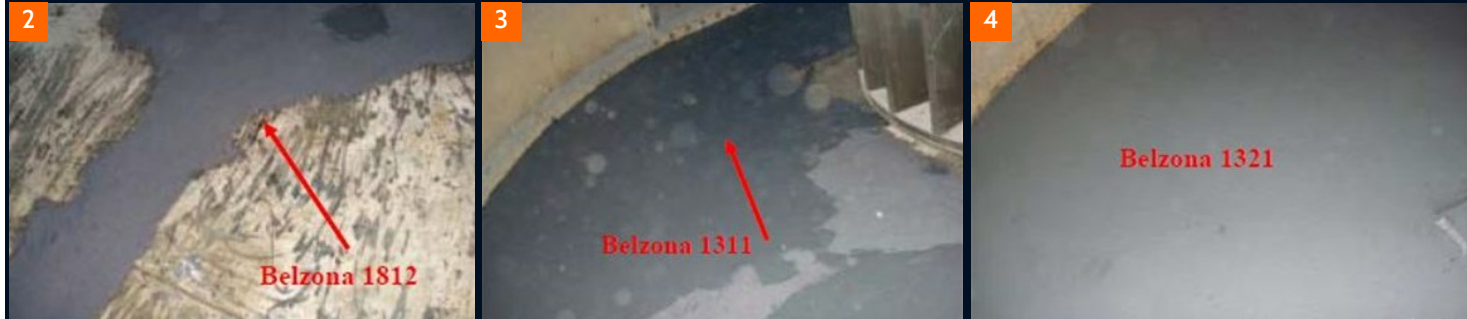
1. Bottom of the flotation cell showing corrosion areas
2. Holes repaired with Belzona 1812
3. Holes repaired with Belzona 1311
4. Bottom of the flotation cell coated with Belzona 1321

This application was carried out in accordance with Belzona Know-How System Leaflet TCC-3. First, the bottom of the flotation cell was washed and the ore residue removed, the surface was prepared with an electric grinder, and the area to be coated was cleaned. After that, the areas with severe wear were repaired with a layer of Belzona 1812, approximately 3 mm thick, to store the thickness of the surface. Then, Belzona 1311 was applied on the remaining worn areas of the bottom of the flotation cell. Finally, the entire bottom area of the flotation cell was coated with Belzona 1321.
