# BELZONA REPAIRS ROAD ROLLER'S SHAFT

ID: 5225

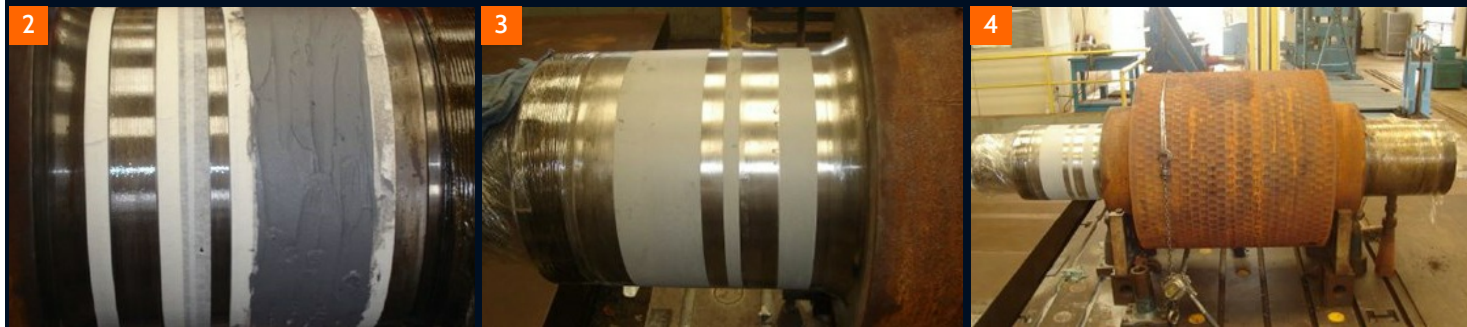
The shaft of a road roller presented wear with thickness loss at the bearing seat area, which was probably caused by occasional seizure. It was necessary to repair this area with a product that had excellent mechanical strength so that the part could return to normal operation. Operating conditions: Temperature < 93°C (immersion); 200°C (dry).

1. Worn shaft before the repair
2. Application of Belzona 1111
3. Shaft after the repair and machining
4. General view of the equipment after repair and machining

Repair was carried out in accordance with Belzona Know How System Leaflet MPT-1. Surface preparation was obtained by machining, leaving the affected area with a coarse and rough thread profile. Afterwards, cleaning was carried out with a degreaser. Belzona 1111 was applied on the prepared area, and the excess was removed by machining, thus obtaining the required dimensions. Equipment dimensions: weight: approximately 8.5 tons. Diameter: 440 mm. Recovered width: 200 mm.
