# BELZONA REPAIRS ROOF LEAK

ID: 5259

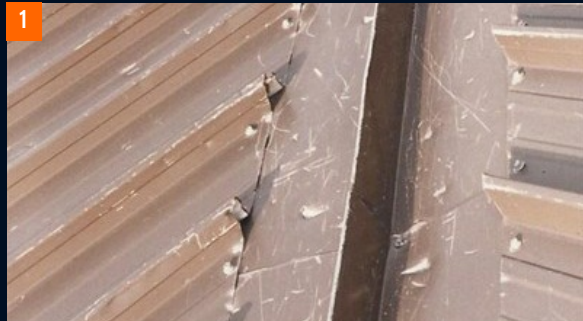
Continual ice build up in the valley forced water under the roof panels due to poor roof design, causing leaks. Someone decided to remove the ice with an ax, causing holes and more leaks.

1. Valley flashing showing ax holes
2. Brushing on Belzona 3921
3. First coat of Belzona 3111 with reinforcing sheet
4. Completed application
