# BELZONA REPAIRS ENGINE BLOCK

ID: 5264

Engine block.

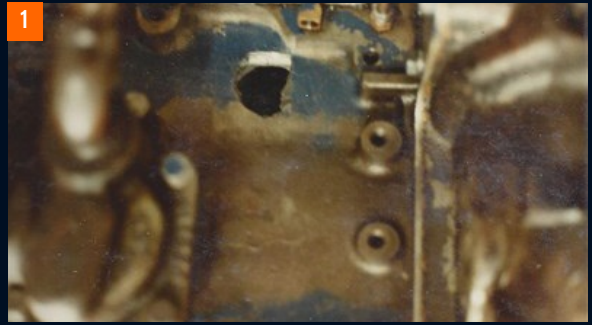
A hole in the engine block allowed the oil to leak out.

A broken connecting rod went through the block. The owner replaced the rod but did not know what to do about the hole. Belzona repaired the hole, solving the problem for the owner.

1. The engine block showing the hole
2. The cracks have been stabilized by drilling the extremities
3. A plate was bonded over the hole using Belzona 1111
