# BELZONA RESCUES A SNOW PLOW HYDRAULIC PUMP

ID: 5268

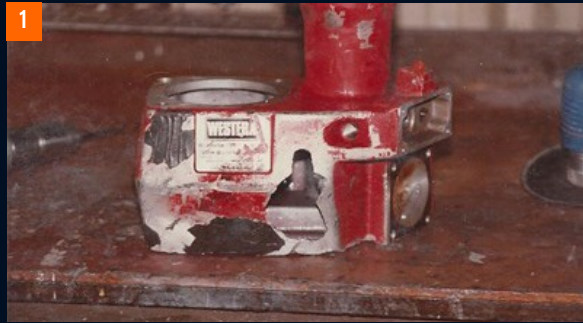
The pump had been repaired with brand X, fell apart after five minutes of use.

1. Aluminum pump casing showing the remains of Brand X failure
2. Casing prepared with grinding
3. Finished casing ready for service.
