# BELZONA REPAIRS CRACKED ENGINE BLOCK

ID: 5269

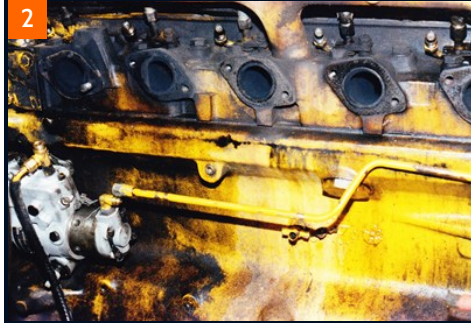
An early freeze allowed ice to crack the engine casing.

1. JD 444 loader with cracked engine block
2. Crack along the length of the engine block
3. Surface preparation by grinding and inserting studs
4. Completed application; Belzona 1111 seals the crack

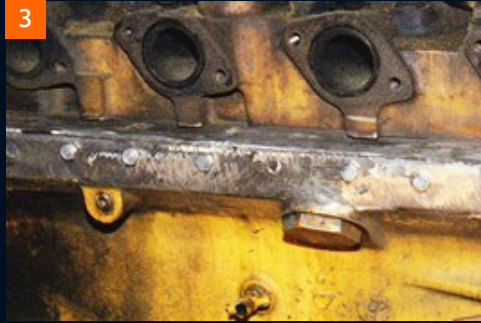
Cracked casing leaks antifreeze.

The application was carried out in accordance with Belzona Know-How System Leaflet ENC-1. The area was ground, studs placed every 2 inches and then covered with Belzona 1111 and Belzona 9341.
