# BELZONA REPAIRS CRACK ON ENGINE BLOCK

ID: 5270

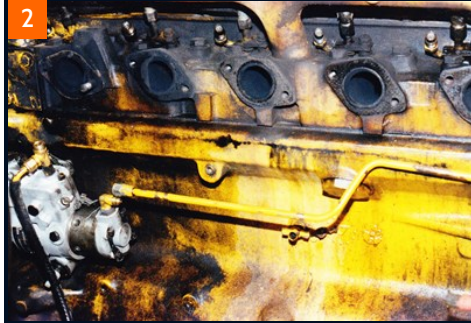
An early freeze allowed ice to crack the engine casing.

Cracked engine casing leaks antifreeze.

1. JD 444 Loader with cracked engine block
2. Engine showing long crack in water jacket
3. Area prepared with studs in place
4. Completed application

The application was carried out in accordance with Belzona Know-How System Leaflet ENC-1. The area was ground, studs placed every 2 inches then covered with Belzona 1111, incorporating Belzona 9341.
