# BELZONA REPAIRS PROFILE OF HYDROELECTRIC DAM

ID: 5285

Rebuilding the profile of a small hydroelectric dam.

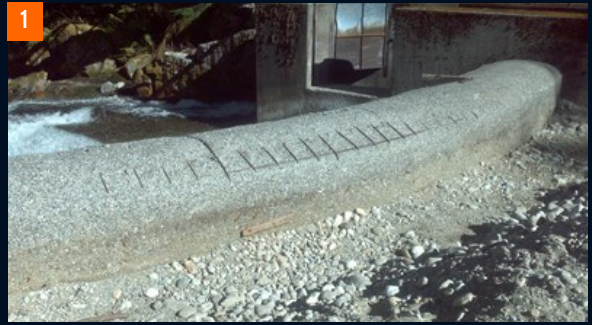
The profile of a small hydroelectric dam became worn, exposing reinforcing bar, which was caused by damage from VW sized boulders tumbling into and over the face of dam during spring runoff. The client was concerned about maintaining the integrity of the small hydroelectric dam and restoring the original profile.

1. Dam (ogee) profile before repairs
2. Several pallets of Belzona 4111 on site
3. Dam repairs underway - note templates & mixer
4. Completed application
