# CONVEYOR BELT REPAIR SAVED COAL TERMINAL DOLLARS AND DOWNTIME!

ID: 5286

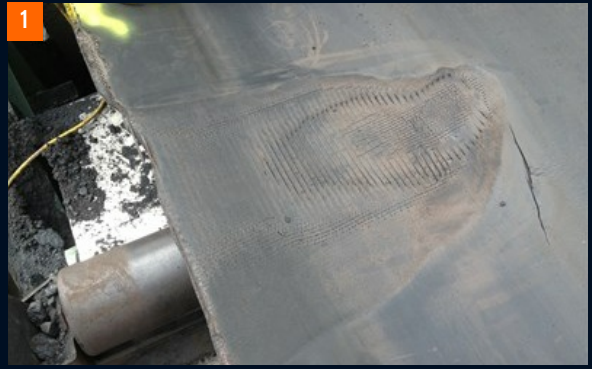
Conveyor system had to be ready for use the following Saturday to unload a ship. Coal conveyor belt caught on roller and "burned" the belt. The terminal could not wait for a vulcanized repair so Belzona was contacted to see if problem could be remediated using Belzona 2000 Series polymers.

2' x 2' sq area was heavily damaged by the belt catching on roller.

1. Damaged belt
2. Technician preparing the repair area
3. Belzona 2911 applied; Ready for Belzona 2111 and Belzona 2121 and tape
4. Application completed
