# BELZONA REINFORCES AND PROTECTS TURBINE

ID: 5323

GE Turbine.

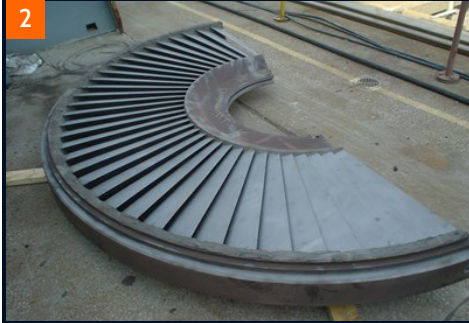
The GE Turbine was partially disassembled for inspection. 7th stage blades being replaced in HP turbine section. Stationary diaphragms of last two stages of LP turbine section were removed for inspection and it was determined that they had been rebuilt with Belzona 1311 two outages prior (16 years ago!). The customer wanted to ensure many more years of service.

1. Overview of the Power Plant
2. Stationary diaphragms removed for inspection
3. Blades showed signs of erosion so they were rebuilt
4. Application carried out for all four diaphragm halves showing one of the four finished repairs
