# BELZONA REPAIRS DRESSER COUPLING

ID: 5329

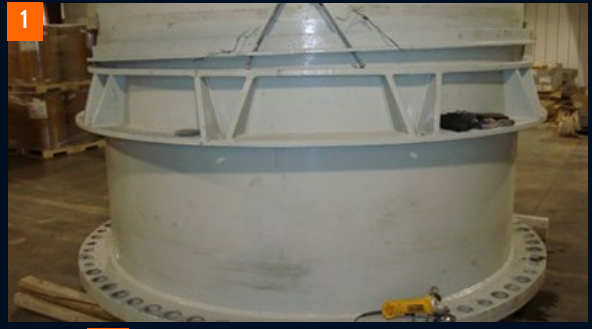
Dresser coupling out of service because it would not seal properly.

1. Dresser coupling
2. Low spot showing prepared surface
3. On-Site Contractor applying Belzona 1111
4. Completed application

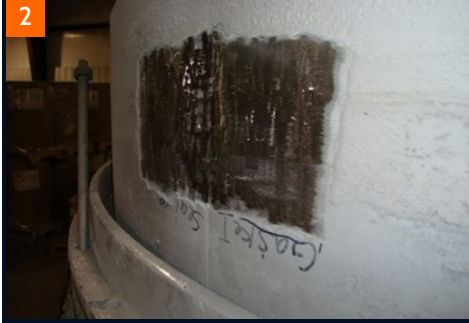
The newly fabricated fitting had a slightly flat spot at the joining weld that would not allow a complete seal with the dresser coupling.

The area of concern was identified and ground to bare metal with a rough finish. The flat area was then rebuilt with Belzona 1111. The proper contour was verified by using a suitable template.
