# BELZONA REPAIRS AND PROTECTS TAPERED SHAFT

ID: 5345

Bull dozer final drive shaft.

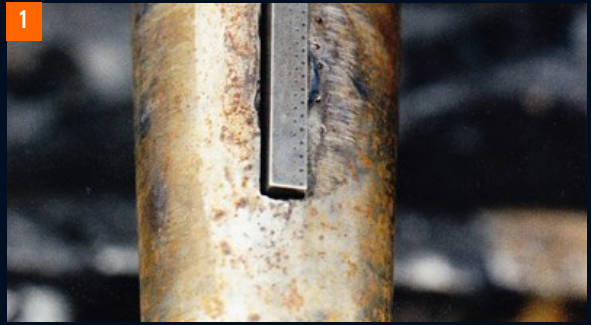
The tapered final drive shaft keyway was worn oversize and the shaft was worn down.

1. Tapered drive shaft showing wear on the keyway
2. Shaft and keyway prepared and Belzona 1111 applied
3. New tapered hub in place centering the key
4. Bull dozer partially disassembled

Application was carried out in accordance with Belzona Know-How System Leaflet MPT-4. The keyway and tapered shaft was ground to roughen the surface. Belzona 9411 was applied to the new key and the new hub. Belzona 1111 was applied and the hub was mounted in place to center the key. The excess of Belzona 1111 was removed. After the cure, the machine was reassembled.
