# BELZONA REBUILDS CHIPPER DISC POCKETS

ID: 5346

Sawmill chipper disc.

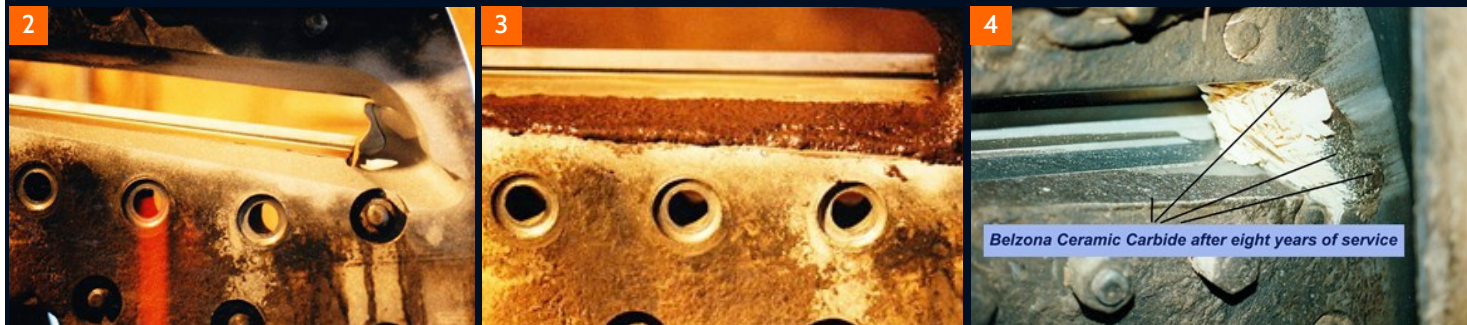
Wood chips wear the cast steel as they slide across the spinning disc pockets. When the pockets wear too far the chips break causing what is called "fines". If this occurs, the price that the mill receives for their chips will be lowered.

1. Worn chipper disc
2. Close up of worn pocket
3. & 4. Chipper disc pockets rebuilt

Application was carried out in accordance with Belzona Know-How System Leaflet SHM-13. The knives and counter knives are removed. The pocket is grit blasted. The counter knives are coated with Belzona 9411 and reinstalled, they are used as a guide for the thickness of the Belzona 1811. Belzona 1811 is mixed and applied to the pocket. Let it cure for 40 minutes to an hour. Wearing rubber gloves, add dish soap to water. Use the mixture to press the carbide chips into the ceramic making a smooth surface. This prevents the chips from clogging the disc.
