# BELZONA REPAIRS A 75-YEAR OLD VALVE FLAPPER

ID: 5350

Hydro Dam Check Valve Flapper

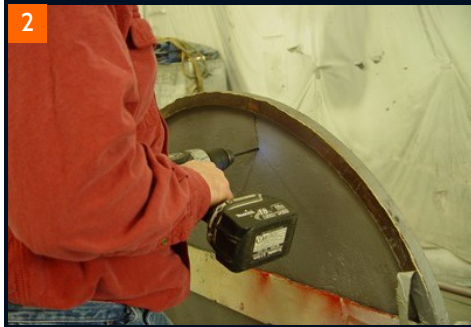
Cast Iron flapper disc had developed a crack. The check valve was 75 years old.

1. Flapper disc showing the crack at 1 o'clock.
2. Drilling the crack to place studs.
3. Area prepared, studs in place.
4. Belzona 1111 applied with reinforcement sheet, applicator taped in place to smooth the seal area.

The application was carried out in accordance with Belzona System Leaflet ENC-1. The plastic applicator was used to form the face in the seal area.
