# BELZONA REPAIRS A CRACKED ENGINE BLOCK

ID: 5366

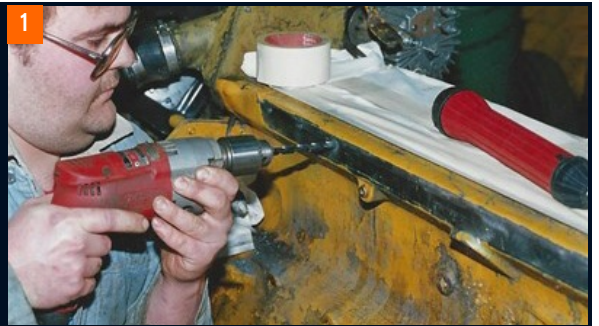
Engine block cracked by freezing water.

1. Drilling holes along crack
2. Threading holes
3. Studs installed, grinding surface
4. Reinforced Belzona 1111 applied to seal the crack
