# FLANGE REPAIR KEEPS PUMP GOING

ID: 5370

Cracked flange on cooling water pump.

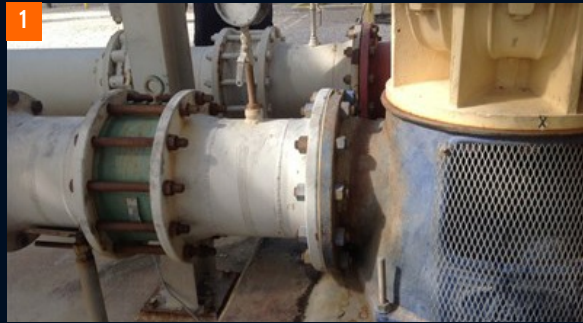
1. Overview of the pump and flange before the repair
2. Belzona 1121 used to build up the area and the composite wrap applied
3. Completed project
