# BELZONA REBUILDS ERODED FLANGE FACE

ID: 5394

Eroded flange face

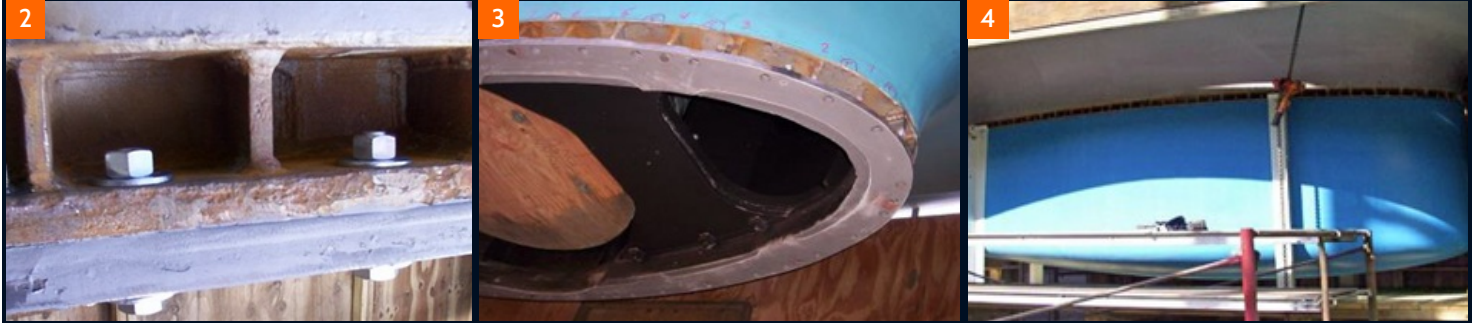
The mating flange on the underside of the vessel was badly warped and eroded, making it difficult to install the new component effectively. The use of rubber gaskets were not 100% effective.

1. Close up of flange showing spacers glued in place to take up the required gap.
2. The flange former was systematically tightened, squeezing out the excess material which was wiped away before it hardened.
3. Application completed.
4. Sonar dome in place.

The application was carried out in accordance with Belzona Know-How System Leaflet GSS-8.

Restoring the flange face with Belzona 1121 allowed the process to be fast and cost effective, saving the customer from the costly replacement of a new section. Belzona repairs always provide a 100% seal and long lasting service time.
