# BELZONA REPAIRS DRILLING MACHINE THREAD

ID: 5411

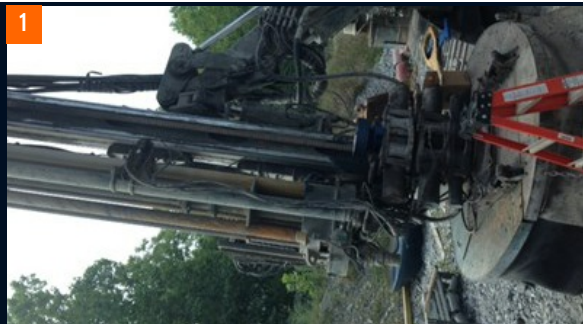
Worn threads on drilling machine would not allow the drill to seal properly, allowing water to leak and lose water pressure.

1. Overview of the drill
2. Male thread being placed underneath the female piece
3. Oversized female thread filled with Belzona 1111
4. Belzona 1111 applied on male thread prior to placing both pieces together to complete the application

The threads were cleaned, using a suitable cleaner/degreaser and a wire brush on the female threads. A release agent was used on a new male thread piece. Belzona 1111 was mixed and applied to both male and female threads. The new piece was screwed into the worn female piece. The excess was wiped off and it was allowed to cure overnight. The new piece was removed in the morning, inspected and then screwed back and sealed. The drill has been constantly used for 2 months now and there are no signs of leakage.

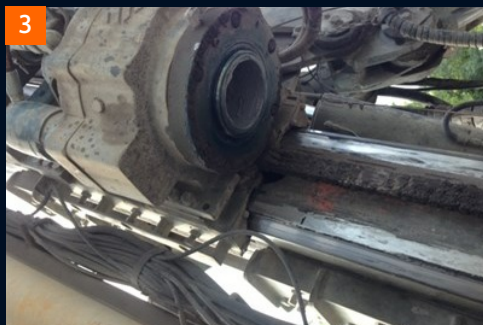
Threads on drilling machine were worn.
