# BELZONA REPAIR OF A SAND PUMP INCREASES SERVICE LIFE

ID: 5426

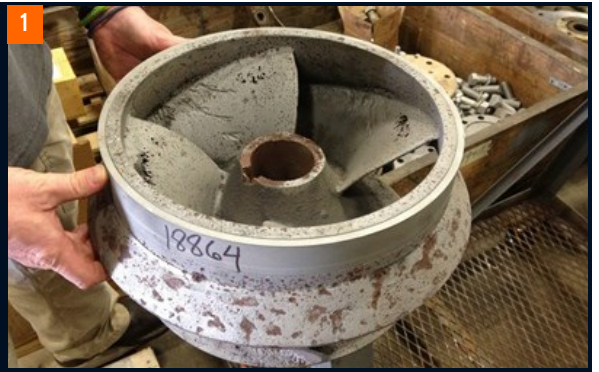
Due to high sand content in the water being pumped, impeller had holes and other areas of metal loss.

1. Impeller upon arrival
2. Holes and other visible damage to be repaired
3. Coated vanes
4. Impeller finished and ready to be re-installed in pump

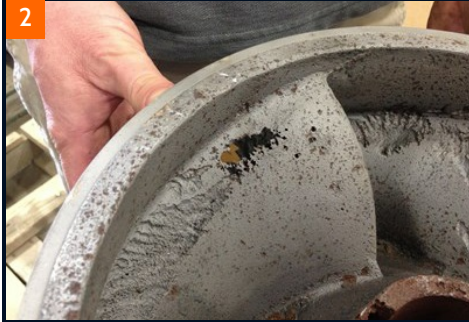
Metal loss and holes in impeller vanes; pitting on outside of impeller.

The application was carried out in accordance with a modified version of Belzona Know-How System Leaflets CEP-1 and FBC-2
