# BELZONA PUMP REPAIR - FROM A TO Z

ID: 543

Centrifugal pump

Water Plant - Egypt

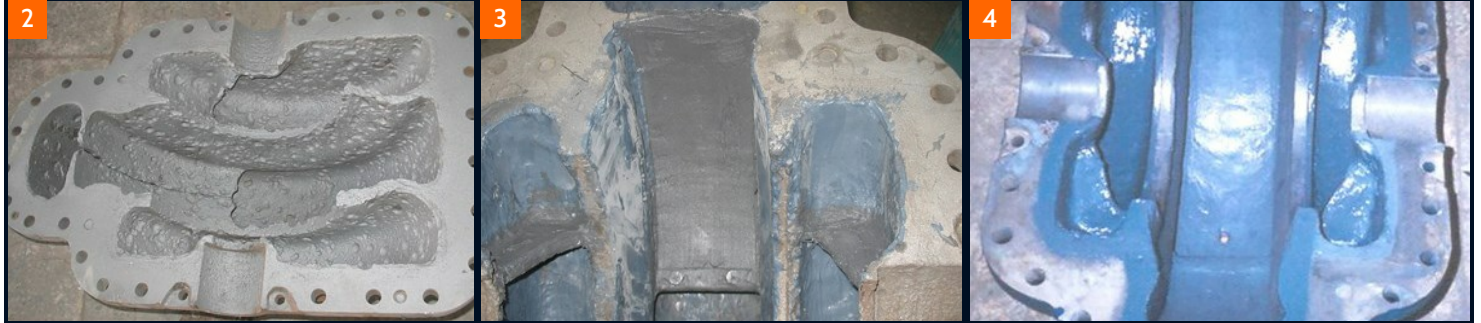
The pump casing, cut water, straighteners, wear ring and gland housing were all suffering from erosion-corrosion. Also, there was a long crack on the cut water.

1. General view of the pump before repair.
2. The pump after surface preparation.
3. Crack of cutwater was repaired and the cutwater and the straighteners were rebuilt.
4. Repair complete. Note how the seats and gland housing were perfectly repaired.

Belzona repaired everything in the pump - from the casing to the cut water and straighteners, including repairing the wear ring seat and the gland housing. In short Belzona returned this pump which was going to be junk to work again successfully saving the replacement costs of new pump and providing more resistance to the effects of erosion-corrosion than new one.
