# BELZONA REBUILDS KILN SUPPORT ROLLER SHAFT

ID: 544

Worn seal area on kiln support roller shaft.

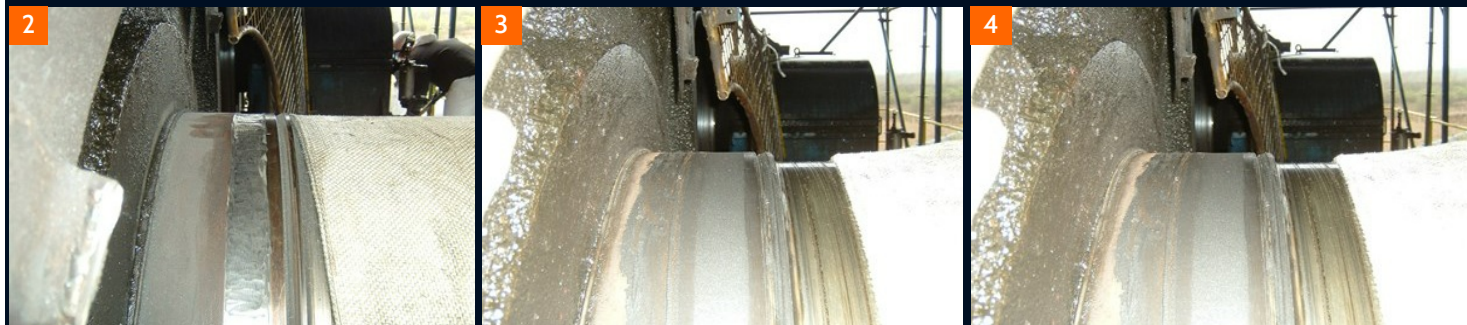
In service the shaft had become worn in the area where the lip seal ran. This allowed oil to leak past the seal resulting in the need for regular oil level checking and refilling as well as a serious slip hazard in the surrounding area.

1. Worn area of shaft
2. View of surface preparation
3. Completed repair
4. Close up of Belzona 1131 repair

The application was carried out in accordance with a modified version of Belzona Know-How System Leaflet MPT-2. The repair was carried out in position. Only the top cradle was removed so application was carried out in two parts. After rebuilding top half, kiln was rotated 180° to allow lower half to be rebuilt.
