# BELZONA REBUILT DAMAGE BOW OF RECREATION BOAT

ID: 5444

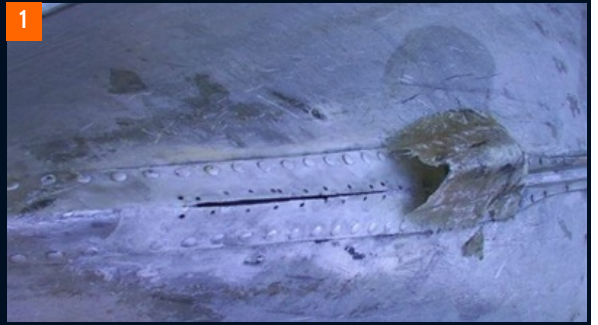
The rivets on the bow that hold the two halves of the aluminum boat shell together would get worn out from the successive beachings.

Rebuilding this area with fiber glass lasted only a single season. The Belzona repair material is heading into its 2nd season unscathed.

1. Condition of vessel bow showing failed fiber glass repair.
2. Bow rebuilt to shape with Belzona 1311.
3. Entire repair further protected with 2 coats of Belzona 1321.
