# OFFSHORE REPAIR OF A RISER PIPE

ID: 5462

12" T-pipe on an FPSO.

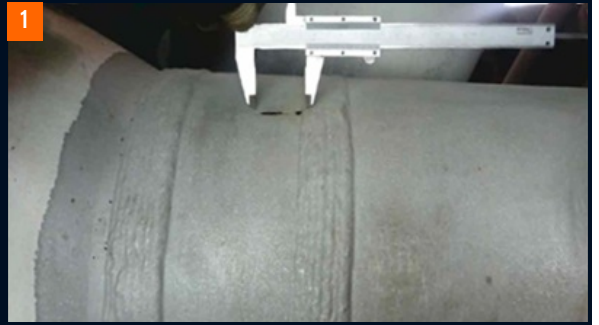
Cavitation near the flange, erosion between flange and T-section. Surface preparation created through-wall defects because of the thin remaining thickness of the pipe at some points.

1. Before repair
2. During internal application
3. External repair - plate bonding
4. Finished repair
