# BELZONA FLOATING ORANGE HOSE

ID: 55

Floating rail hose

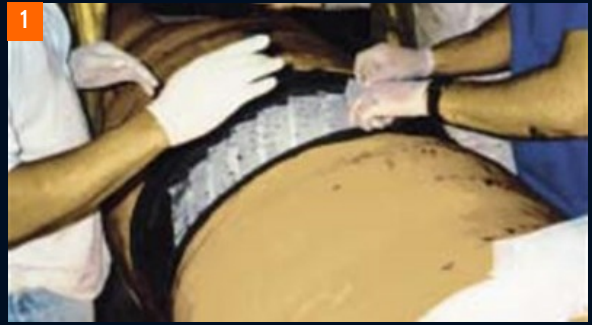
Massive, deep cut in the hose.

1. Repair procedure in progress using Belzona 9341 (Reinforcement Tape) and special layering technique.
2. Belzona 2211 (MP Hi-Build Elastomer) almost cured.
3. Floating hose ready to go.

The application was carried out in accordance with Belzona Know-How Leaflet SOS-12.
