# BELZONA REPAIRS DRIVE SHAFT ON ROLLING MILL

ID: 5510

Deteriorated drive shaft on four high rolling mill.

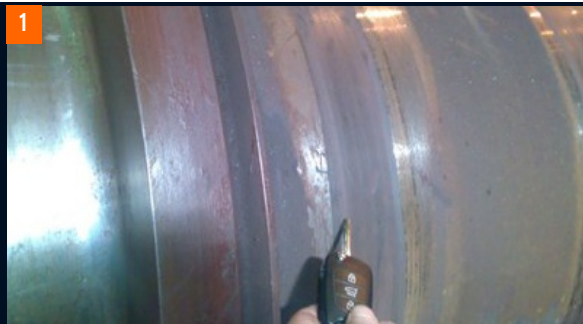
Deteriorated shaft in gasket seating areas (6 gaskets 50-90 m wide with a diameter of 709.25 mm on each shaft) causing excessive oil consumption. Original Belzona application lasted 12 years so the customer immediately turned to Belzona again.

1. Close-up view of the damaged shaft area
2. Prepared surface for the application of Belzona 1131
3. Application of Belzona 1131
4. Completed shaft repair
