# BELZONA REPAIRS DISCHARGE PIPES OF A CYCLONE FEED SUMP

ID: 5532

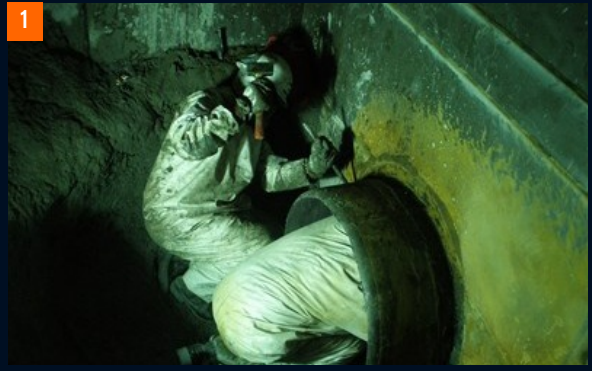
1. Preparation of the surface
2. Injection of the Belzona 4151 to fill the space between the wall and the pipe
3. Repair of damaged concrete with Belzona 4111
4. Belzona 1812 coating to protect against wear caused by abrasion.
