# BELZONA REPAIRS TO CREAMERY MILK RECEPTION FLOOR AREA

ID: 5549

Creamery, Stranraer, Scotland

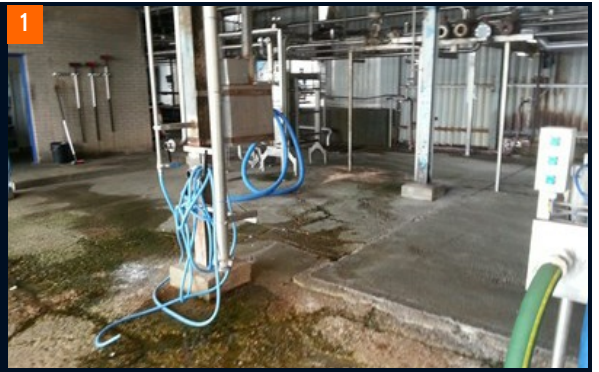
The materials had to be applied and cured in this short time frame. Over the years, the concrete floor had deteriorated due to wear, abrasion and chemical attack from the milk and cleaning fluids used. In some areas, the concrete has become cracked, and in others, it has worn down resulting in an uneven surface. An expansion joint was also in need of replacement.

1. Cracks in the concrete floor
2. Damage from loading product
3. Application of Belzona 4131
4. Completed application

The area was mechanically prepared and power washed to bring out any ingrained chemicals. The application was carried out in accordance with Belzona Know-How System Leaflets FPA-1 and FPA-6.
