# BELZONA STOPS LEAK IN A HYDROPOWER PLANT

ID: 5560

Oil sump reservoir in the bottom of a turbine in a hydro dam.

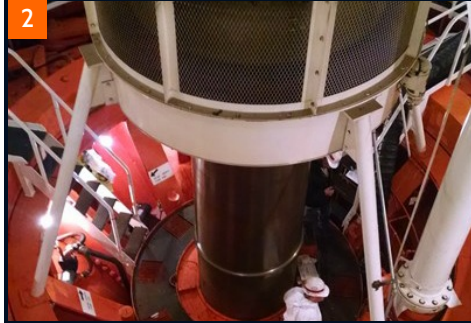
1. Inside the powerhouse.
2. Inside the turbine housing.
3. Active leak.
4. Completed application.

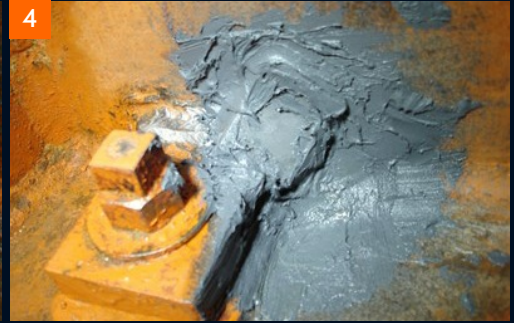
Weld failure at the bottom of the reservoir resulting in an active oil leak, creating a hazard as well as potential ecological contamination.

The existing paint had already been removed to identify the source of the leak. The surrounding surface was properly cleaned and roughened by hand with emery paper. Located at the bottom of a 3' tall reservoir, there was gravitational pressure resulting in a low pressure, slow leak. Using Belzona 1212, an oil tolerant, fast curing material, a small steel plate was bonded over the leak. A second plate was also bonded in a second layer over the repair location to ensure success.
