# BELZONA REPAIRS THE HYDRO PLANT INLET PIPE

ID: 5561

Water inlet pipe of a hydro plant.

Hydropower plant, Usk, WA

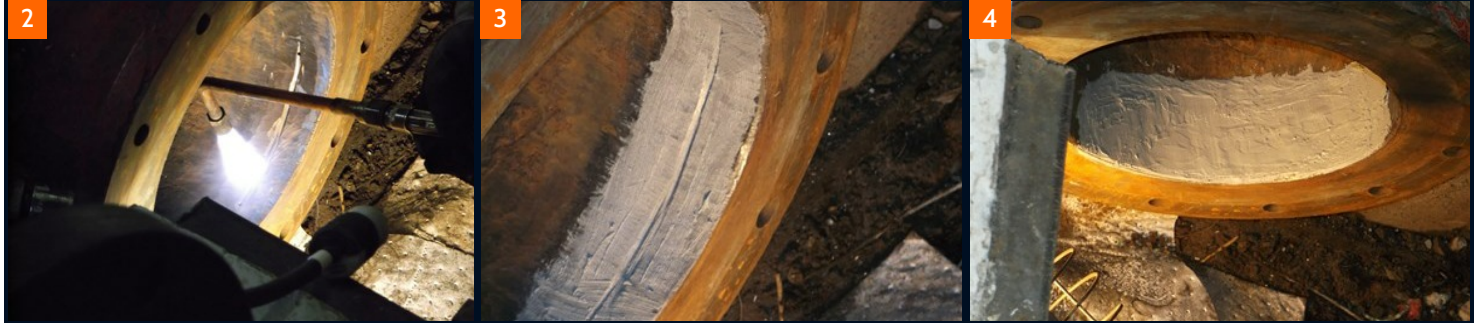
A nearby landslide had shifted the waterline inlet of the hydro project causing extreme pressure on the cast iron pipe near the inlet. This caused the pipe to begin splitting behind the flange due to misalignment.

1. Overview of "vee" out cracks and drilled holes with inserted screws
2. Sweating out with the rosebud torch
3. First layer of Belzona 1111 scrubbed in
4. Completed application

The surface was ground with a coarse grinding wheel to expose the full length of the crack. The crack was "vee'd" out and holes were drilled at each end all the way through, and 75% through every 1". The holes were then tapped and screws inserted and ground off flush to prevent movement in the crack. The area was sweated out with a rosebud torch, and a final surface preparation of grinding was done. Belzona 1111 was scrubbed into the surface and a thin layer applied before laying in a coated piece of Belzona 9341. The application was finished off with a final layer of Belzona 1111.
