# BELZONA 1212 REPAIRS CRACKED TRANSFORMER FIN

ID: 5571

Oil filled substation transformer radiator fin.

Electricity Substation, Washington, USA

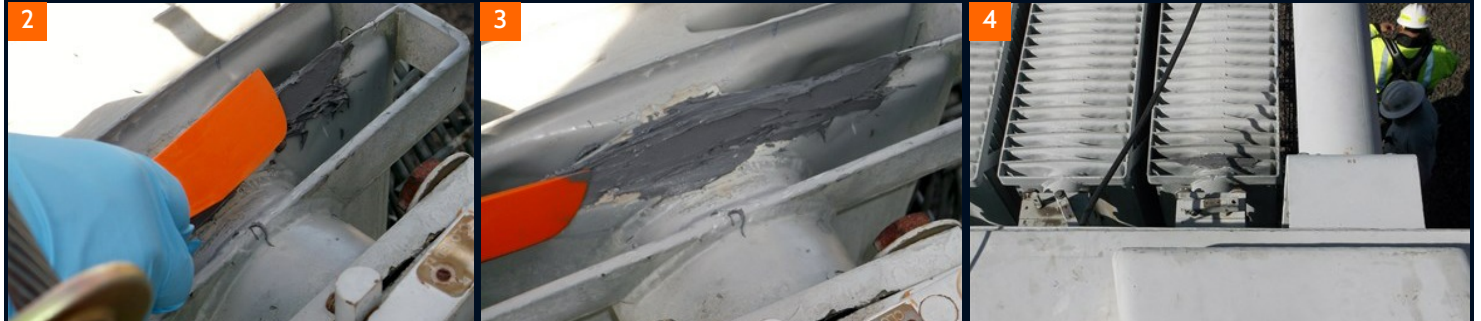
There was a crack on the top edge of the oil filled transformer radiator fin.

The first repair attempt to weld the crack actually developed a new crack next to the weld. This was an active leak, resulting in oil and nitrogen escaping from the transformer. With welding, the problem was only getting worse. The other option would have been to continue welding and possibly needing to drain the oil from the tank, removing the transformer from service for an extensive amount of time. Belzona 1212 allowed for a quick prep and a quick application with a fast cure time. Approximately 1/4 of a unit was used for this repair. After discovering the benefits of Belzona, other opportunities where Belzona can be beneficial to their maintenance program are being explored.

1. Crack with oil present.
2. Applying Belzona 1212.
3. Finishing application.
4. Completed application.

The application was carried out in accordance with a modified Belzona Know-How System Leaflet TCC-1. The paint was removed and the area was prepped with coarse emery cloth. Belzona 1212 was mixed per IFU guidelines and applied with a spatula, firmly pressing down to fill the crack and ensure maximum contact with the surface.
