# BELZONA CRUISE SHIP CENTRIFUGAL PUMP

ID: 56

Main circulating water centrifugal pump

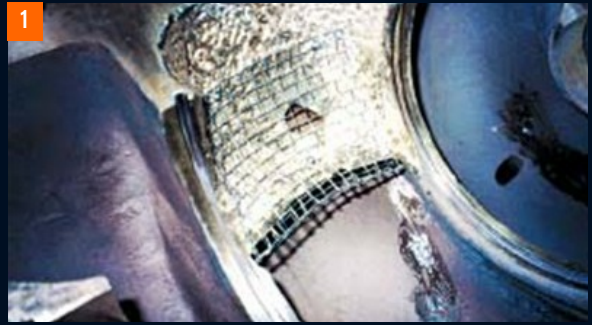
Severe erosion/corrosion damage, evidenced by more than a dozen small holes, and one large hole completely through the casing as well as a loss of up to two inches of the cutwater. The wear ring seats were also eroded in the same area.

1. The pump casing and cutwater after blasting and fitting with expanded metal mesh. Note the hole at the center of the cutwater.
2. Belzona 1311 (Ceramic R-Metal) being pressed through the mesh and into the surface profile of the bronze.
3. The finished application. Repaired cutwater edge and casing holes. The seal area and rebuilt seating groove is on the right.

Application was carried out in accordance with modified versions of Belzona Know-How Leaflets CEP-1, CEP-2, and CEP-6.
