# BELZONA FIXES A CRACKED CUTWATER ON A FAN PUMP

ID: 5616

Cracked casting seam on a fan pump at a paper mill.

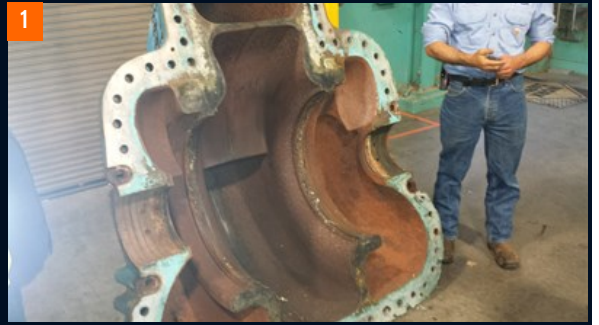
Casting seam on the cut water of this Gould pump had separated and was beginning to erode from being in use.

1. View of pump
2. Grit blasted surface
3. Holes drilled
4. Completed application
