# BELZONA 1111 FIXES THE FIBERGLASS FLANGE

ID: 5654

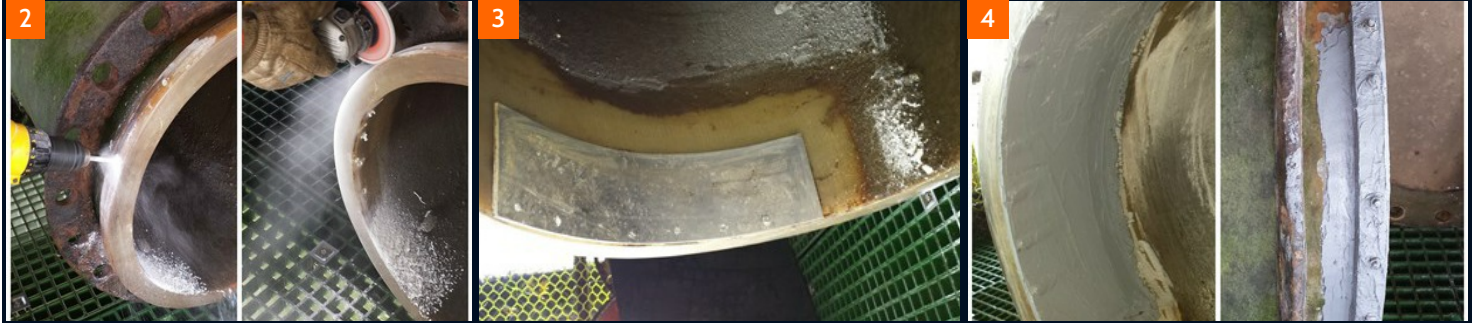
Cracks appearing in the flange and leaking water when the system was pressurized.

1. Preparing the area to expose the crack
2. Drilling and V'ing the crack
3. Steel plate fitted and drilled
4. Completed application, inside and outside

The application was carried out in accordance with Belzona Know-How System Leaflet VPF-9. The ends of the cracks were located and drilled through to terminate the crack. The cracks were worse than originally thought, actually cracking into three different areas. The cracks were then drilled every 1" and V'd out. A thin, mild steel plate was fit to the inside of the pipe with holes drilled in it as well matching the pipe. Both the steel plate and fiberglass pipe were prepped by grinding where Belzona 1111 was to be applied. Belzona 1111 was mixed and applied to the fiberglass pipe, carefully pushing it into the crack and holes. The steel plate was mounted inside the pipe and mounted with bolts and then covered with a thin layer of Belzona 1111. The exterior portion of the crack was smoothed over to allow the metal collar to still fit on the flange.
