# BELZONA REBUILD TRENCH DRAIN AT PAPER MILL

ID: 5684

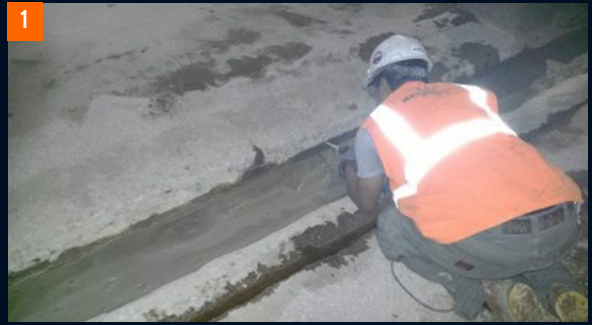
The concrete holding up the grate was so damaged that the grate fell into the trench.

1. Edges being prepared while drain is in use
2. Forms used to rebuild edges with Belzona 4111
3. Grate replaced over the trench
4. One year later, still performing well

The application was carried out in accordance with Belzona Know-How System Leaflet FPA. Loose concrete was chipped away and the edges were ground. A wood former was used to rebuild the edges to the original width and height.

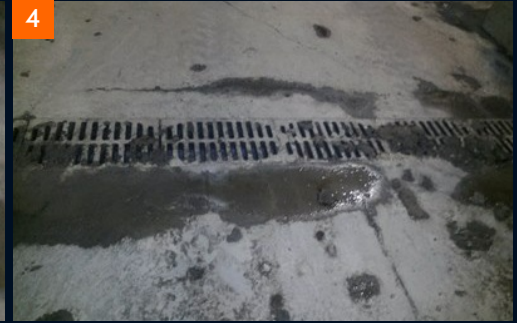
One year later, the drain is in perfect condition. A conventional repair would have cost 10 times more and eliminated the use of the next room beyond the drain for two weeks. The Belzona repair took 18 hours, including cure time.
