# BELZONA REPAIRS DAMAGED GEAR BOX

ID: 569

Service vehicle gear box

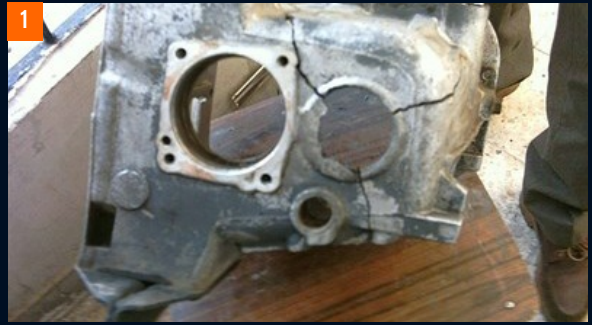
The gear box was badly cracked and fractured.

1. Fractured gear box
2. Stabilizing the long cracks of the gear box
3. Using metal strips to reinforce the crack
4. Repair completed after applying Belzona 1111 to the cracked surface
