# BELZONA TAIL SHAFT REPAIRS

ID: 574

Ships tailshafts (three)

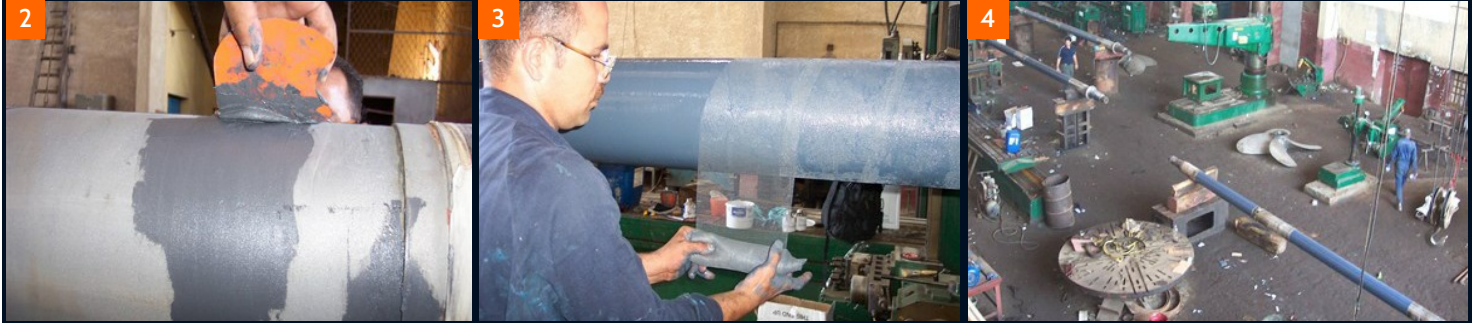
Corrosion due to failure of fiber glass wrapping.

1. Corrosion pitting shown.
2. Rebuilding the corroded areas.
3. Applying Belzona Reinforcement Tape between the first and second layers of Belzona 1321.
4. Three tailshafts were repaired and protected.

Belzona repaired the corroded tail shafts, returning them back to dimension without machining. Belzona® 1321 is a corrosion resistant coating and is the best choice for long-term protection to this type of equipment.

Belzona 1311 (Ceramic R-Metal)  
Belzona 1321 (Ceramic S-Metal)
