# BELZONA SEALED THE LOCK

ID: 5758

Lock and Dam on the Arkansas River

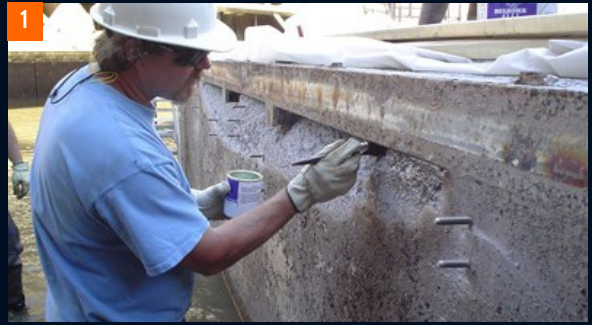
Damaged concrete below the seal plate let water leak into the lock.

1. Lumber placed in the lock
2. Belzona 4111 built up damaged area
3. Completed repair top view
4. Completed repair side view

The application was carried out in accordance with Belzona Know-How System Leaflet FPA-1. 16 foot 2x4's were drilled and put into place on the dam. Plastic was used as a release agent and the void was filled with Belzona 4111.
