# BELZONA RESTORES RISER OF OIL & GAS PRODUCTION PLATFORM

ID: 5823

4" diameter riser on oil & gas production platform.

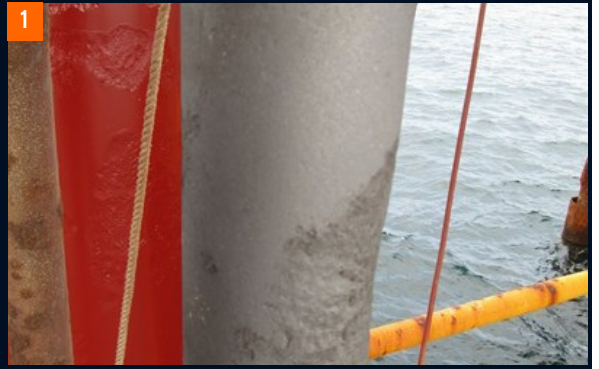
Riser suffering from corrosion due to the offshore environment required the restoration of metal loss and protection from further deterioration. The asset owner was interested in a compliant composite solution. A metallurgy survey determined there were three sections of the riser that required the installation of SuperWrap II.

1. Condition of riser after abrasive blasting.
2. Belzona 1982 applied in 5 wraps (10 layers).
3. Belzona 9382 installed to consolidate the repair.
4. Completed application - overall view of the three riser sections installed.

The area to be repaired was grit blasted to produce SSPC-SP 10 (Near White) with a minimum anchor profile of 3 mils. Belzona 9111 was used to clean and degrease the blasted surface. Belzona 1121 was used to fill pitted areas and restore original wall thickness. Belzona 9381 was saturated with Belzona 1982 and applied onto the riser in 5 wraps (10 layers) in compliance with the engineered design. Belzona 9382 was used to consolidate the repair and removed after the 24 hour curing process.
