# BELZONA RESTORES OFFSHORE CRANE ROOF

ID: 5828

Crane roof on offshore production platform.

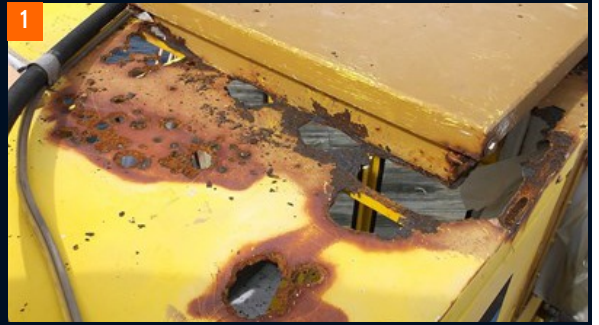
Severe corrosion deteriorated the crane roof, causing hole through/thin wall defects and loss of structural integrity.

1. Crane roof before restoration.
2. Crane roof after grit blasting.
3. Plate bonding installed using Belzona 1121 to adhere plates.
4. Completed application - fully reinforced two coat system of Belzona 3111/9311.
