# BELZONA SUPERWRAP II UPDATES RISER

ID: 5894

4" and 6" risers on offshore production platform.

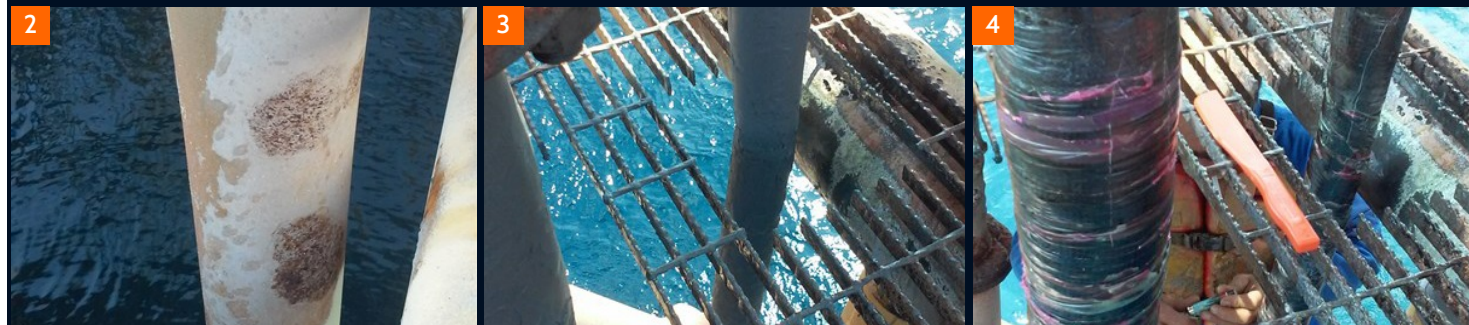
External corrosion was creating thin wall defective areas with potential loss of structural integrity. The asset owner wanted to restore the integrity of the pipe wall by employing a compliant repair solution without downtime and loss of production.

1. Condition of riser before abrasive blast.
2. Riser during blast showing defect areas.
3. Rebuilding the substrate with Belzona 1121.
4. Completed application of Belzona SuperWrap II.

The repair area was abrasive blasted to achieve SSPC-SP 10 (Near White Metal) with an anchor profile of at least 3 mils. The surface was wiped clean with Belzona 9111 and maintained clean until commencement of the application. Belzona 1121 was used as a rebuilding material to fill pits and restore the original thickness of the wall. Belzona 9381 was saturated with Belzona 1982 and applied around the riser in 5 wraps (10 layers) in compliance with the engineered design. Then, Belzona 9382 was installed to consolidate the repair during the curing process. Once the system was cured, Belzona 9382 was released.
