# BELZONA AVOIDS LONGER DOWNTIME

ID: 5897

Francis turbine cone.

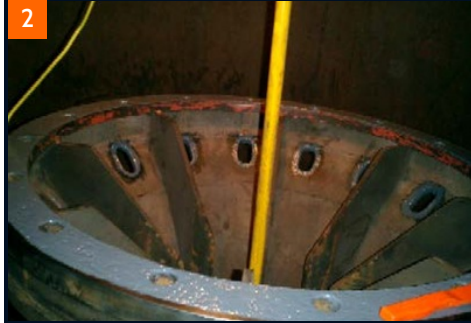
Wear on the flange caused sealing problems and erosion/corrosion on the cone's border. Total disassembly of the unit would cause a longer downtime.
