# BELZONA SAVES THE BULL GEAR

ID: 5924

Ore processing Ball Mill bull gear.

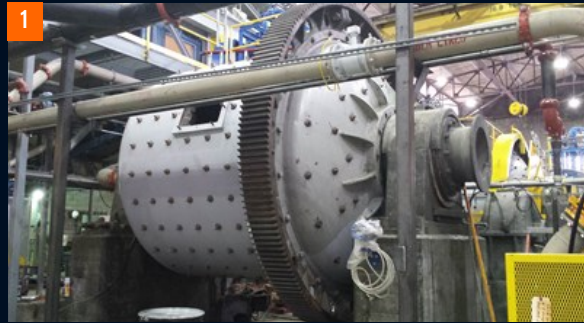
1. 1 of 5 Ball Mills.
2. Erosion damage cleaned and grit blasted.
3. Application of Belzona 1111.
4. Application of Belzona 1321.

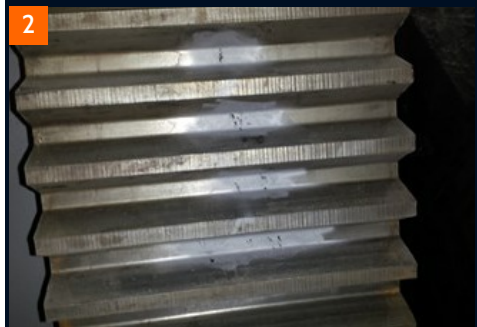
The gears on this Ball Mill bull gear were experiencing erosion and pitting.

The application area was thoroughly cleaned with solvent and then grit blasted to prepare the surface. All erosion damage was filled in with Belzona 1111 and followed with a brush on coating of Belzona 1321 to protect against further damage.
