# BELZONA KEEPS THE BELT MOVING

ID: 5925

## PROBLEM

The edges of the conveyor belt were separated due to a failure on the bonding area.

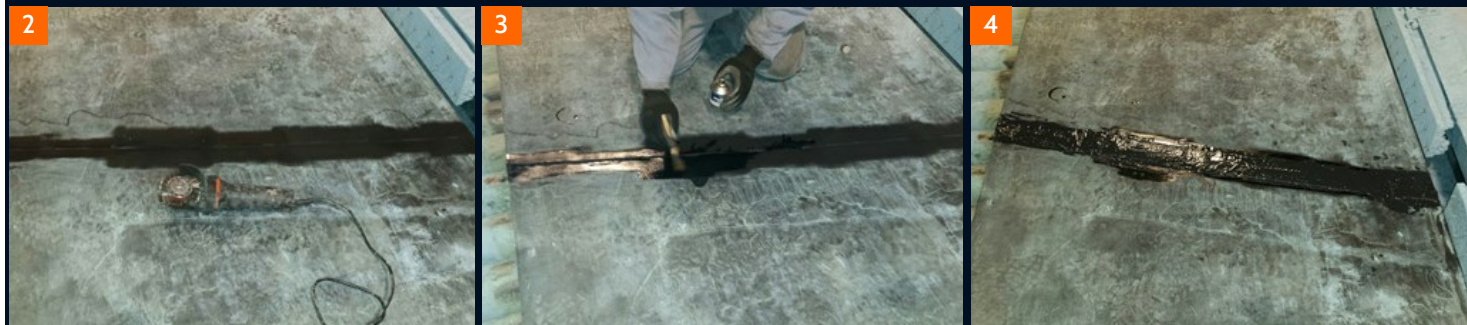
1. Close-up view of the separating seam.
2. Surface prepared with the MBX Bristle Blaster.
3. Application of Belzona 2911.
4. Completed application.

The surface was prepared with a MBX Bristle Blaster for a rough finish and optimum bonding. Belzona 2911 was applied while being careful not to touch it after application. Belzona 2211 was mixed and a short bristle brush was used to scrub the first layer into the roughened rubber. Additional Belzona 2211 was applied to Belzona 9341 and it was applied over the seam. The remainder of Belzona 2211 was applied over the top and smoothed for a clean finish.
