# BELZONA ENGINE BLOCK REPAIR SAVES BIG MONEY

ID: 5927

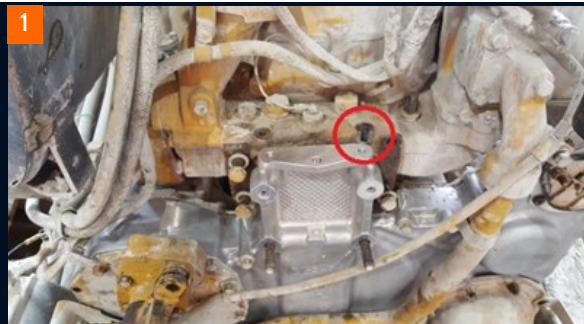
A bolt for a mounting bracket was broken out from the engine block.

1. Broken bolt housing
2. Surface cleaned and roughened
3. Application in progress
4. Bolt removed, ready for reassembly
